Heat technology – technical support

Below are described some errors, which the technicians could meet in the field and what are the possibilities of resolving this problems.

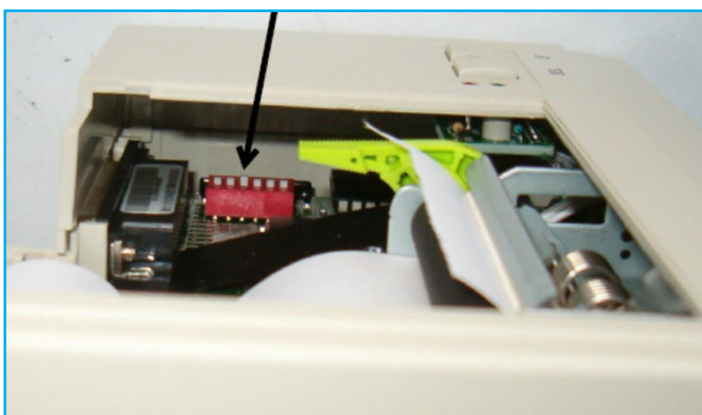
Figure 2-10 DIP Switch Setting

1) If the customer's printer is not working, the cause of the problem may be in incorrectly set switches or not properly connected cable:

a) Switch 3 is not in the "ON" position. After the so - called "switch setting" the printer, it is necessary to turn the printer off and on again, so that the new configurations of the switches are saved to the memory.

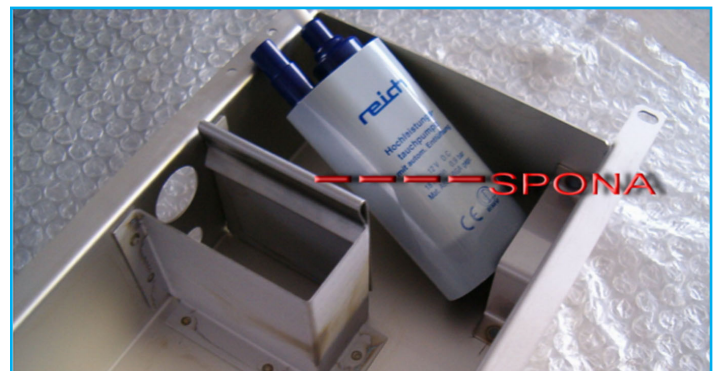
Image Location of the frame

2) Error 24 is reported in Climacell - A float switch is located fairly close to the drain pump. The float switch uses the principle of a reed relay, in which there is a magnet placed in the float and relay in the solid part that contracts or expands depending on the distance of the float. Magnetic field of the pump was influencing the position of the float and the automatic system had subsequently interpreted it as an error, the sensor gets blocked and does not switch, even though it is not faulty. With a magnetic plate (frame) the magnetic field of the pump has been shielded (image Location of the frame).

In this case it is necessary to perform a test - to solve the problem by placing a magnetic stainless plate - a special frame - onto the shield-barrier around the level sensor. The construction has been modified and the problem should not occur again - it was something that is not described in the manual. If a plate is already in place, then the level sensor might probably be faulty. It needs to be checked, whether the barrier is made of magnetic stainless steel - magnet.

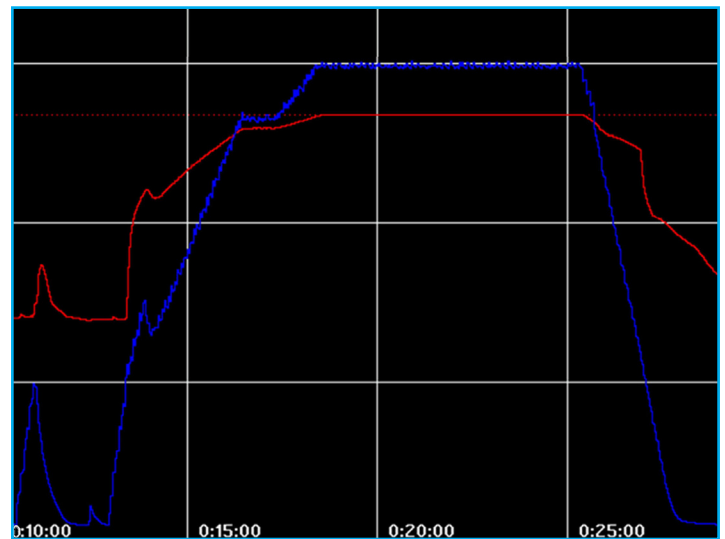
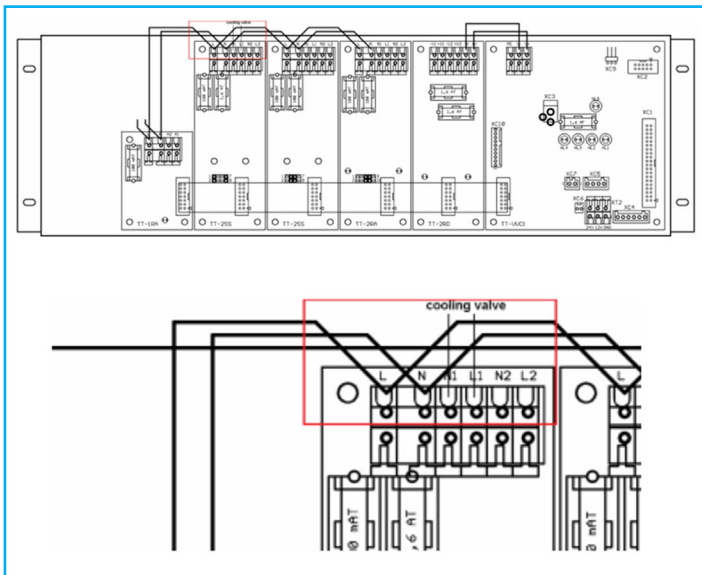
Image Connection diagram

3) Modular system - faulty plates - the image shows one of the causes of defect of the modular system plate - for some unknown reason, damage is being done to a electrical relay (SSR). If that happens, 230 V will not be measured on the clamps N1/L1 (image Connection diagram), as it should be, but for example 168 V. Defect of this plate may then cause destruction of the controlled valve - either it will get overheated, will start oscillating or loud knocks will be heard.

When the plate is damaged, there are bad signals for - either / or: cooling valve, freezing valve, generator valve, fan.

The modular plate has been replaced; the new one should be more resistant.

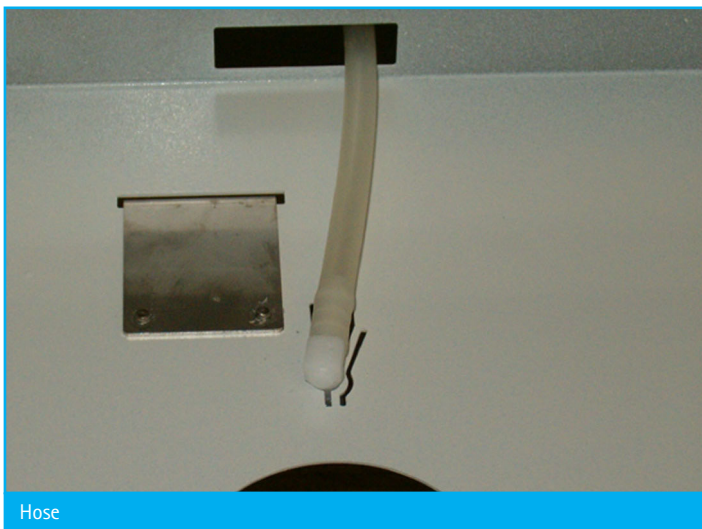
Hose

4) Sometimes, water drips out of the generator of CLC. This might be because the drain hose has shifted from its correct position (see image Hose). End of the hose - a plastic joint - must be secured to the bottom plate. It also depends on the length of the hose installed in the device. If the hose is longer or shorter, the joint may shift to the side on the bottom and then is no longer aligned with the generators properly and as a consequence, water drips out on the generator. Sometimes, it is sufficient to place the same hose - about 5 cm long - on the other side of the joint pointing towards the generator. When attaching the generator must then be ensured that the tube was secured in the correct position - directly into the condensation tank of the generator.
